### 5.3 INCISAL ANTERIOR RESTORATIONS

#### 5.3.1 UNILATERAL ABRASION ON THE CENTRAL INCISOR

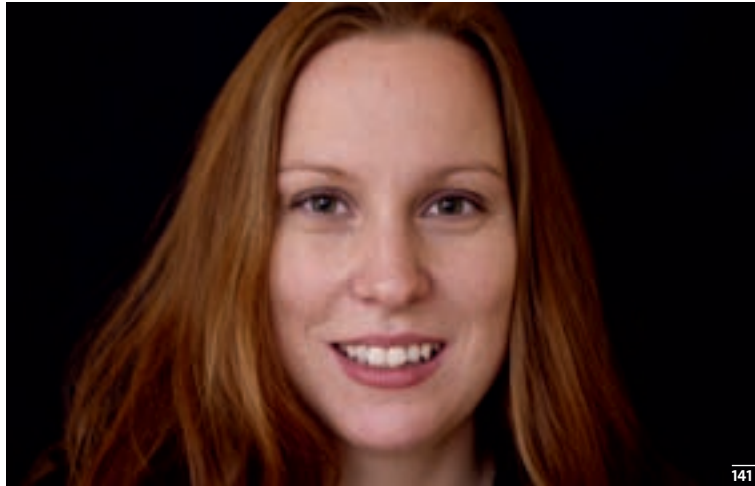
**Fig. 141** The distal incisal edge of tooth 21 of this patient was fractured and showed slight wear. The woman patient had always been bothered by the asymmetrical curve line of her incisal edges. However, after having heard about minimally invasive options, she decided at this point in time to have her substance defect restored.

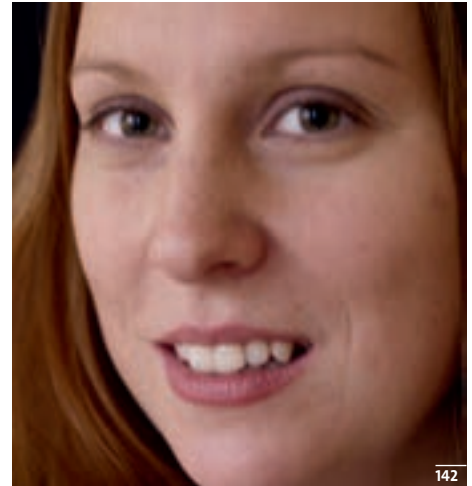
**Fig. 142** Compared to the laugh line, the missing distal corner of the incisal edge produced a discordant contour there.

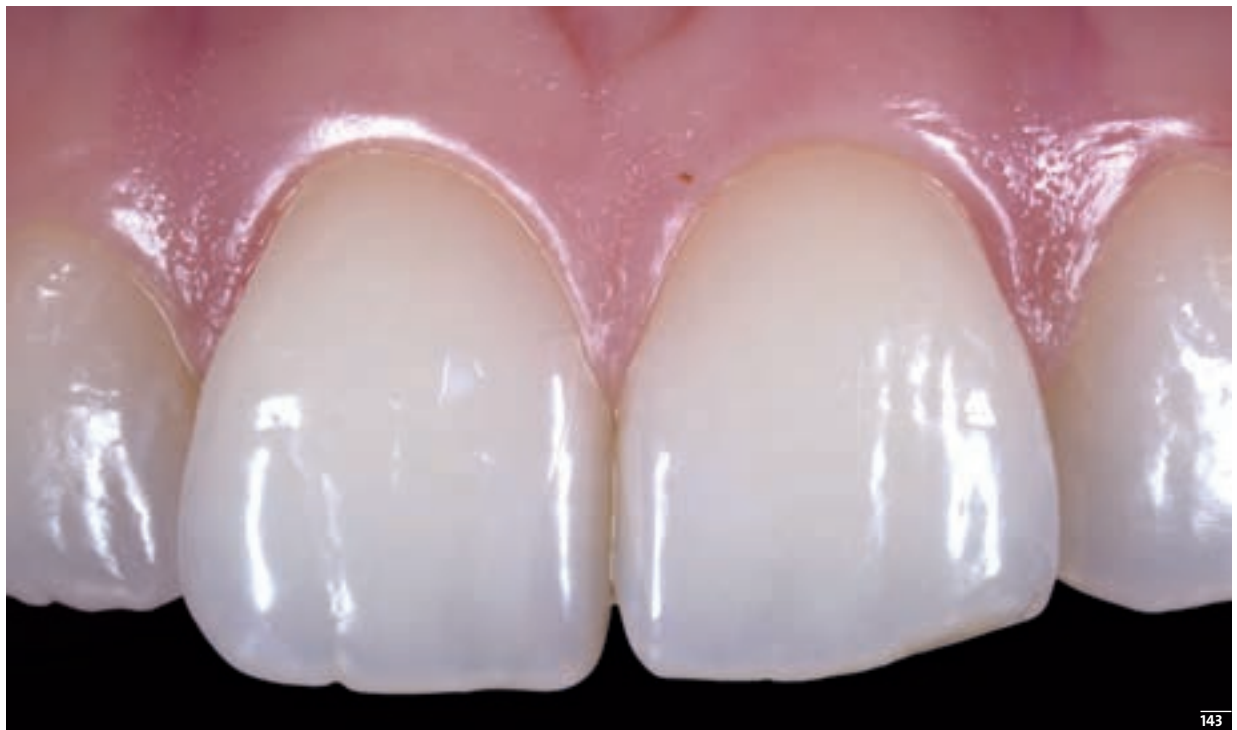
**Fig. 143** Analysis of the contours of the anterior teeth revealed a distally ascending curve of the incisal edges of the anterior tooth zones. However, this impression was created only because of the missing disto-incisal edge. Although the loss of substance was relatively minor, the defect obviously produced a discordant relationship between tooth width and tooth length. This fact underscored the impact and functionality of the human perception. Any deviation in proportions of the teeth among each other is perceived as discordant, if not even distracting. Thus, it was understandable that, despite this apparently minor substance loss, the woman's aesthetic sensitivity was bothered enough by this defect to convince her to have it restored by a dentist.

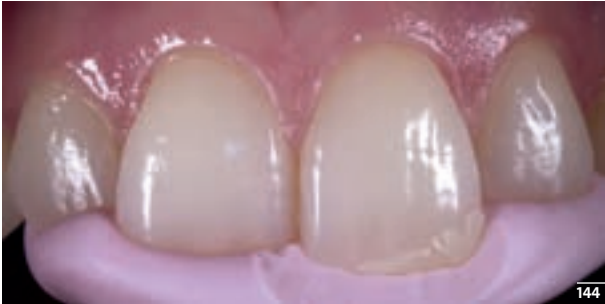
- Fig. 144** On tooth 21, a provisional and diagnostic mockup was fabricated and tried in (see Chapter 3.2) under functional considerations. Next, a silicone impression was taken of the anterior teeth.

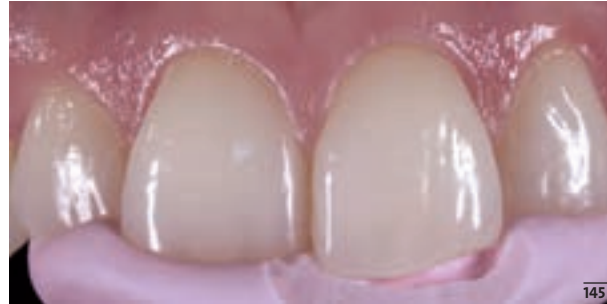
- Fig. 145** The mockup was removed after the silicone material had hardened. As a control, the silicone matrix was pressed palatally onto the dental arch. The incisal edge area to be built up on tooth 21 was clearly visible.

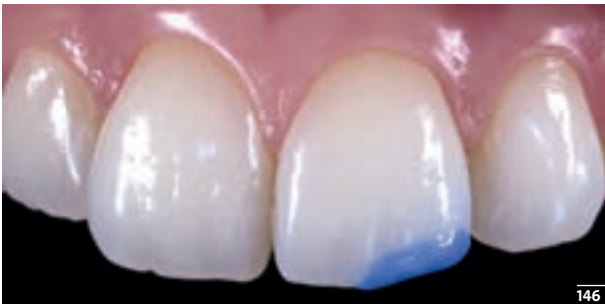
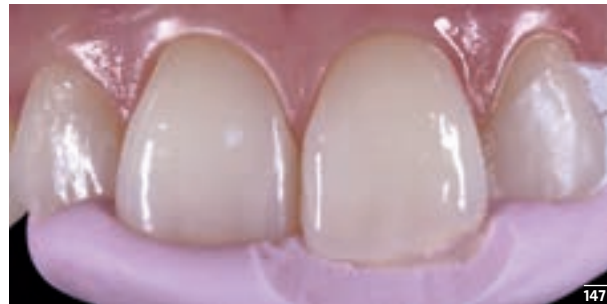
- Fig. 146** The tooth surface of tooth 21 was conditioned with etching gel (UltraEtch, Ultradent) and then bonded (OptiBond FL, KerrHawe).
- Fig. 147** To isolate tooth 21, the adjacent tooth was covered with Teflon tape (the tape turned transparent from wetting with primer and bonder). A thin layer of transparent composite, shade T1 (Venus, Heraeus Kulzer) was placed in the silicone matrix, and pressed palatally onto the tooth with increasing pressure. Then, the composite was light-cured.

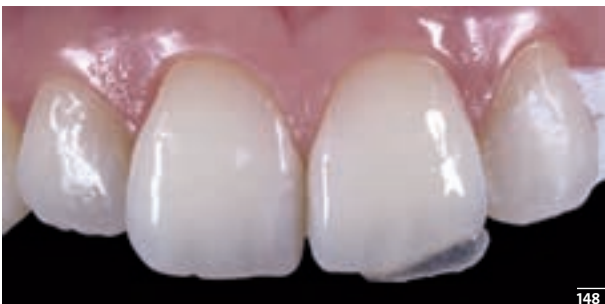
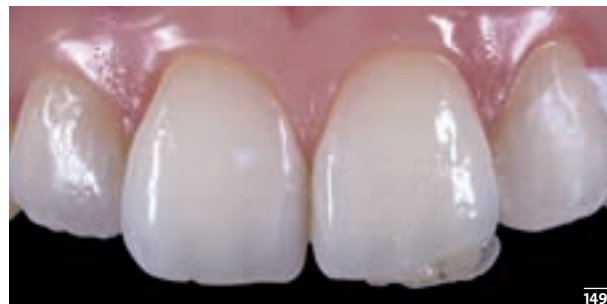
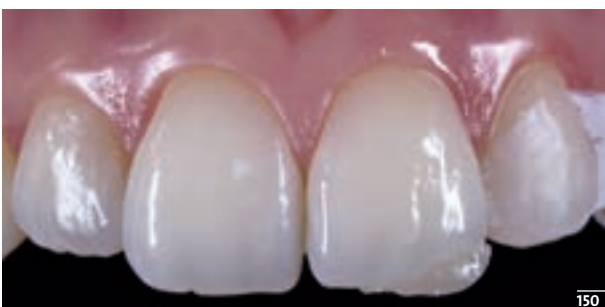
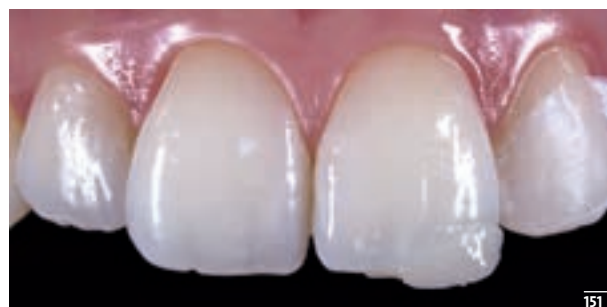
- Fig. 148** The hardened palatal shield comprised a delicate, primary and stable wall.
- Fig. 149** The first layering component was an opaque dentin material A2 (Venus, Heraeus Kulzer) applied like mamelons (dentin tubules) on the shield.
- Fig. 150** An enamel material with the shade Enamel A2 (Venus, Heraeus Kulzer) was layered over the dentin layer.
- Fig. 151** A final layer of a translucent, cloudy effect material T2 (Venus, Heraeus Kulzer) was applied to mimic the brightness level of the natural tooth.

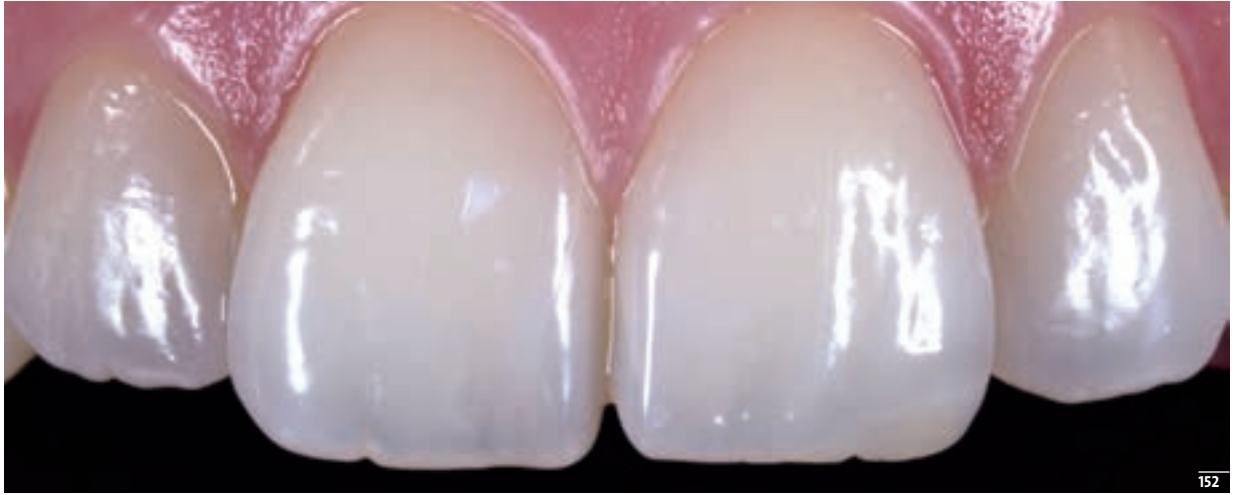
152

- Fig. 152** After the incisal edge of tooth 21 was finished and polished, its shade corresponded almost perfectly to the distal edge of tooth 11. A virtually invisible reconstruction was achieved.
- Fig. 153** Even in the lateral view, it was obvious that the structures of the distal portion of the incisal edge descending into proximal area had been reconstructed realistically.
- Fig. 154** When its interplay with the neighboring teeth was viewed from a greater distance, the restoration merged harmoniously into the arch. The proportions of the contour elements were concordant. With minimal therapeutic measures such as replacing a small portion of the disto-incisal edge, the initially uneven looking curve of the incisal edges in the maxilla was compensated to perfection.

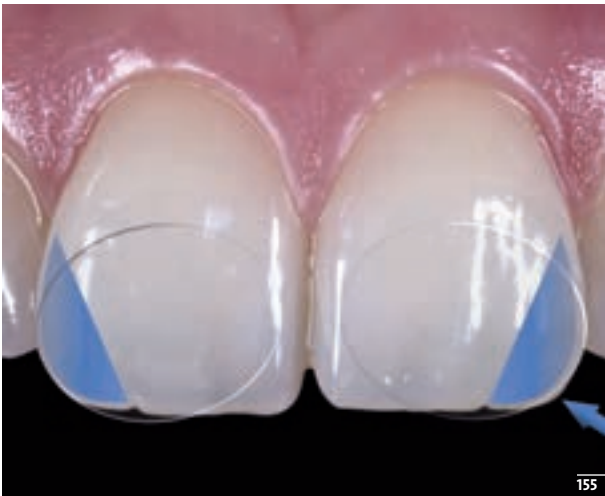
- Fig. 155** To check the quality and extent of the reconstructed, shape-determinant portions of tooth 21, ellipsoids were projected onto the tooth surface (see Chapter 2.1). This allowed comparison of the incisal edges of 11 and 21 with each other. Analysis of the blue geometrical figures revealed that the contours of the distal incisal edge of tooth 21 largely mirrored those of adjacent tooth 11. The oblique, ellipsoid form perfectly traced the curve of the disto-incisal edge of tooth 11, although a minor deviation was evident on tooth 21 (see arrow). Apparently, there was a little excess restoration left.

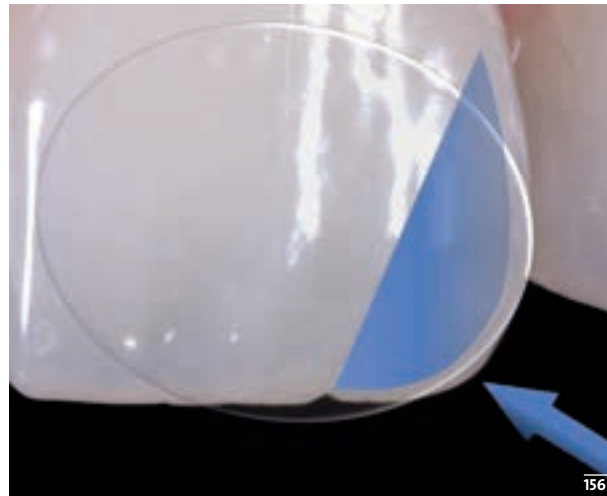
- Fig. 156** Under magnification, the excess portion of the restoration appeared slightly too large, but was not noticeable in the original size. Therefore, it was left as it was.

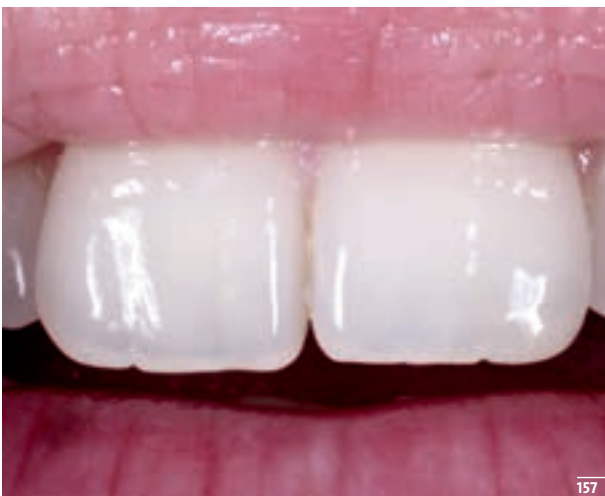
- Fig. 157** Close-up, the distinctive central incisors look virtually identical in terms of their shape. The shades of teeth 11 and 21 blended seamlessly into their surroundings. In this sense, the goal of "Restitutio ad integrum" was certainly accomplished – everything was restored to its proper state!
